RE: *Port Authority of NY & NJ Loss Control Report - World Trade Center Complex*

World Trade Center
LIFE SAFETY ENHANCEMENTS
Resulting from Experiences during
the Terrorist Bombing

Engineer: Vincent E. Sbarra, P.E. File No. 93160-01
Date: April 26, 1993

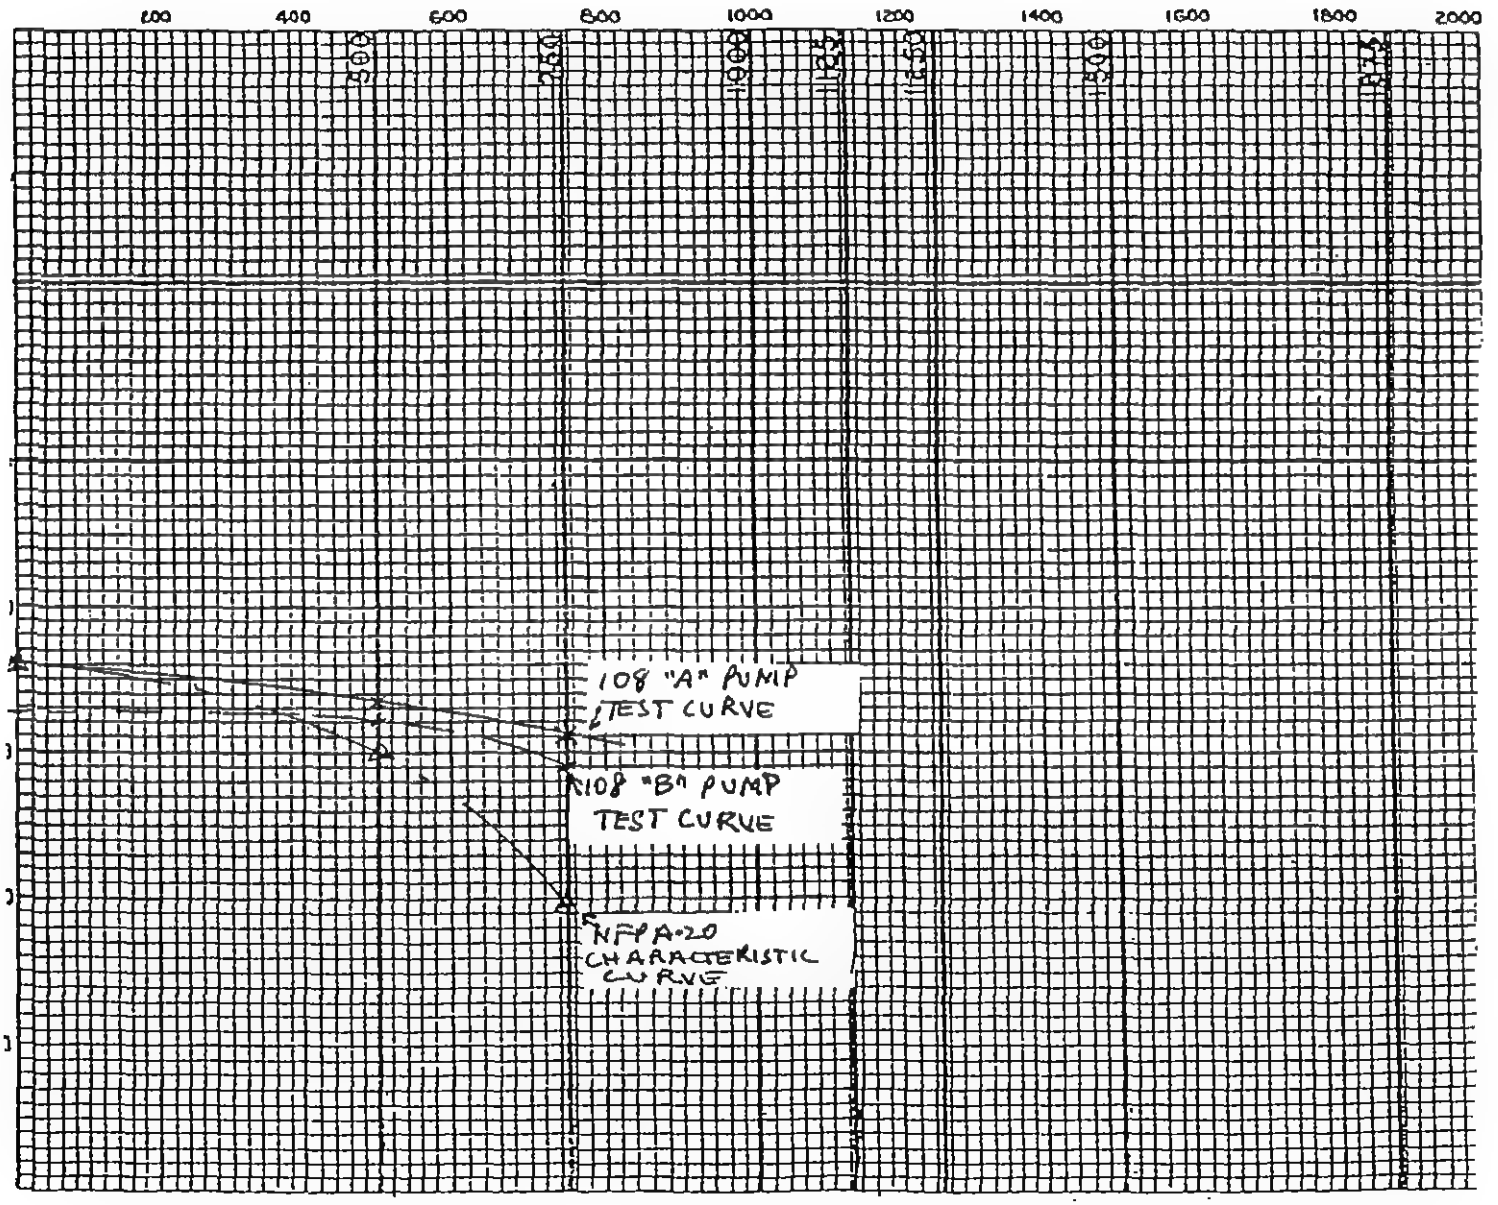
SPRINKLER PUMPS

Test results are satisfactory. RCD recommends relocation of the 3/4 inch circulating relief valve on 108 "B" sprinkler pump from the suction side to the discharge side. The 108 "A" pump has not been equipped with such a valve and RCD recommends that one be provided per NFPA20, 2-6.
